Case Studies

eNtisa Eskom projects

JUNE 2019

Nelson Mandela University
Authored by: Mr Donnie Erasmus

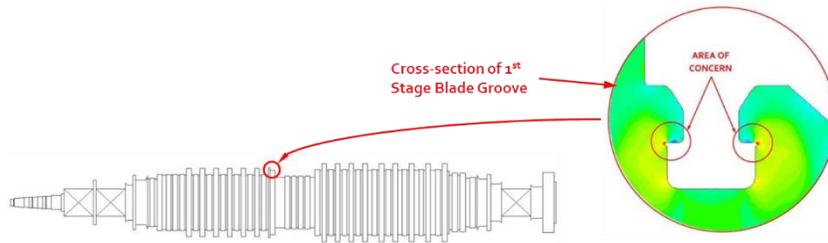
- The area of concern was identified, as indicated below, at the corner radii of the blade attachment groove pull face
- The accumulated creep strain (300kh) at the blade groove ring was estimated by FEA in an attempt to determine whether the actual observed damage by Replicas at the outer surface can be used to estimate the damage at the inner surfaces
- However, the initial model used the minimum creep properties but to accurately calibrate the model the actual observed material damage at the corner radii is required
- As seen a Replica cannot feasibly be taken at the pull face, position, necessitating an alternative technique for inspection
- The extracted sample would therefore need to incorporate the corner radius area for analysis

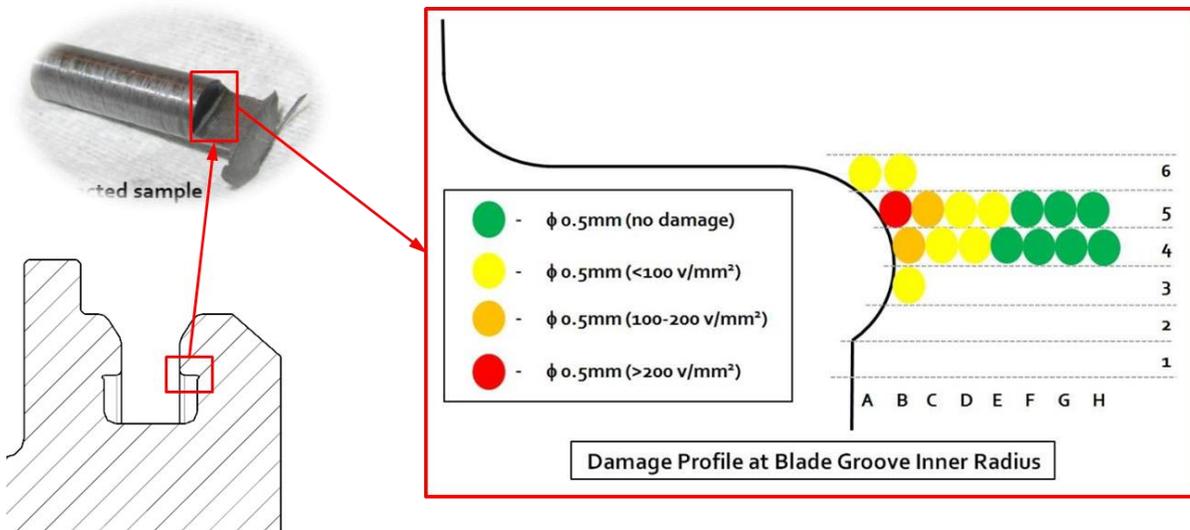
- Creep damage assessment was conducted on the extracted samples where typical void counts (voids per mm²) were seen, as depicted below

- The samples extracted provided crucial creep condition information to assist with rotor management decisions
- Direct measurement of creep damage can assist with calibration of FEA models and become an important methodology in the management of remnant life of high value engineering components - beyond specified design life
- The WeldCore® Sampling Procedure has to date been applied to four identical turbine rotors - three out of four rotors could be returned to service for a further 10 years after damage was machined away

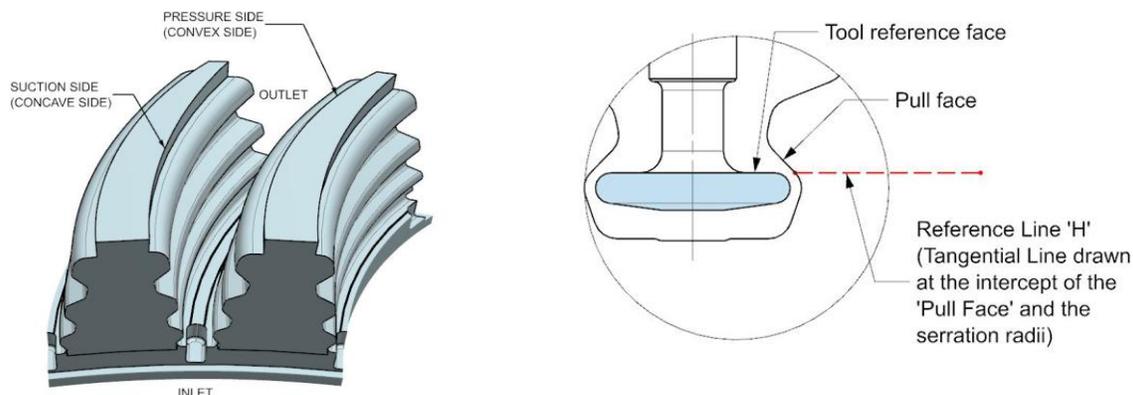
- Stage 5 displayed the most severe SCC on both suction and pressure side.
- Stress analysis indicated that offloading occurs to the middle and lower serrations, as cracks propagate through the top convex-side serration. Stress in the lower serrations increases due to offloading, but peak values remain lower than design top serration peak values for cracks or excavations.
- Complete loss of the top serration results in significant offloading to the bottom serrations. Nonetheless, only limited local areas of yielding are expected with the reference stress well below the yield strength.

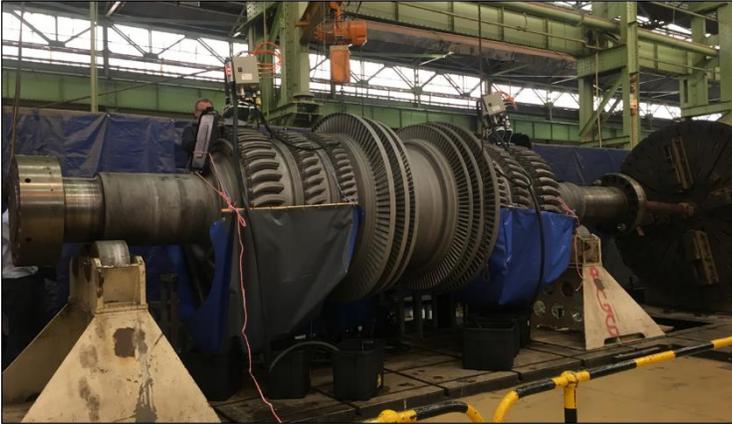
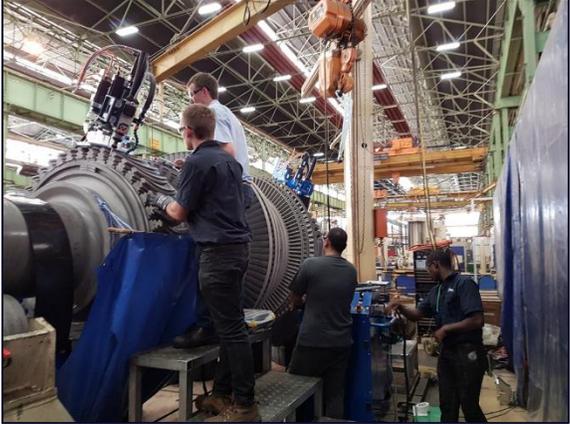
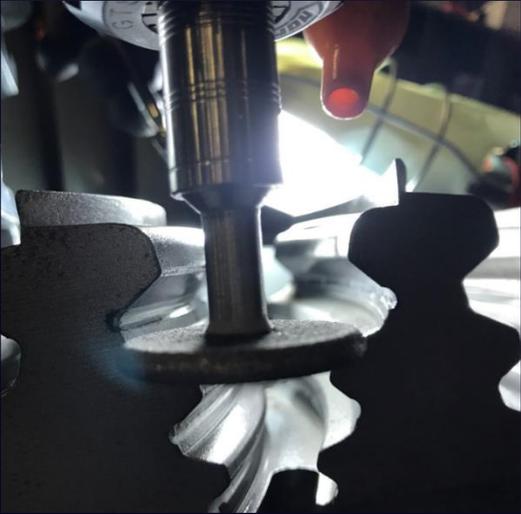
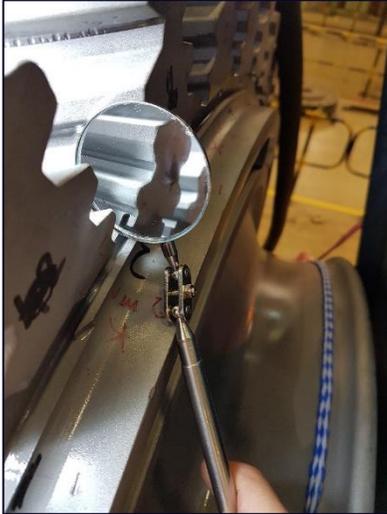
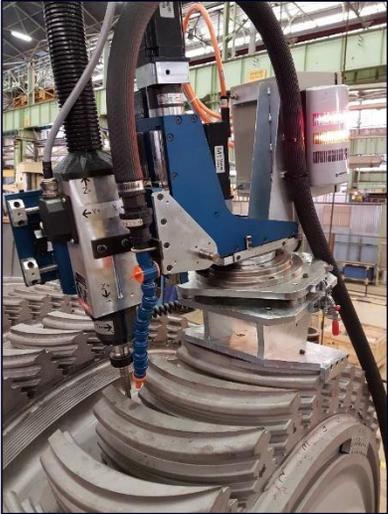
Top two images indicate the rotor and a team on site performing rotor serration grinding, the lower images are of the tools utilised and the completed grind

- eNtsa developed a system capable of grinding all the serrations on the steeples of stage 4, 5 and 6 up to a depth of 5mm on Kendal LP rotors.
- The system is also capable of removing individual cracks within the serrations or pockets along the length of the serration.

- During the application this was performed on all individual cracks, mainly evident in stage 5, all additional serrations were ground to depth of 0.5mm as preventative measure.

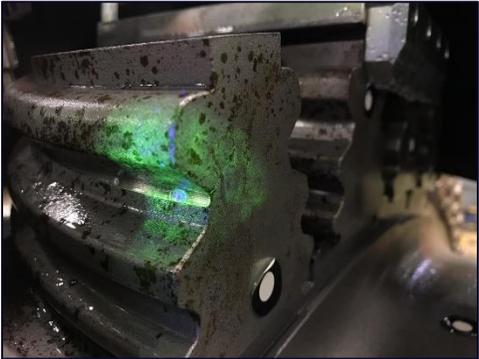
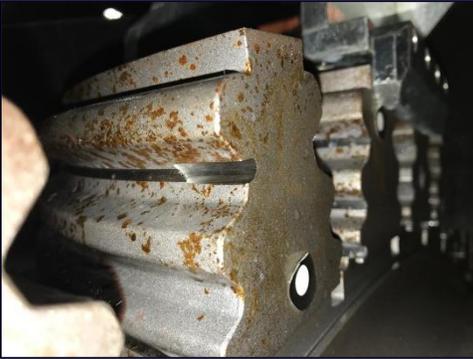
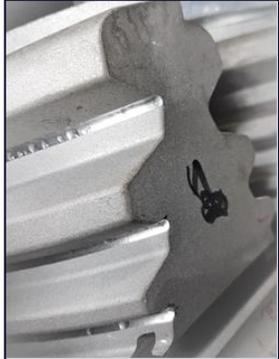
Images above: Before and after images of crack and serration post grinding
